Manhole Inspection Summary

Manhole # S31CC_024MH

Insp Date: 1/30/07 11:01 AM

Location Address: **EUTAW ST**

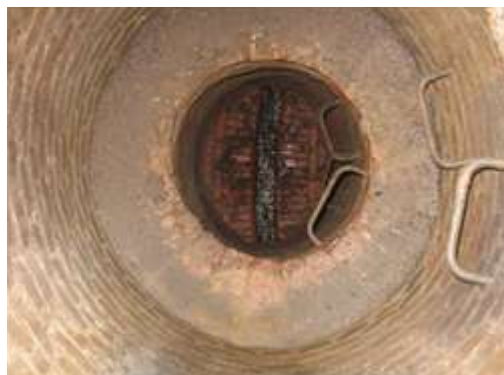
Top View

Bench debris. Corroded steps.

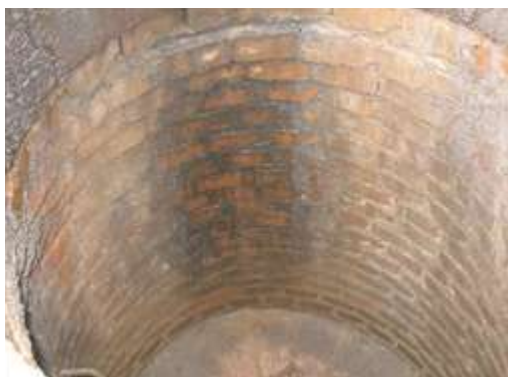
Defect

Frame leaks. Adjustment deterioration and infiltration.

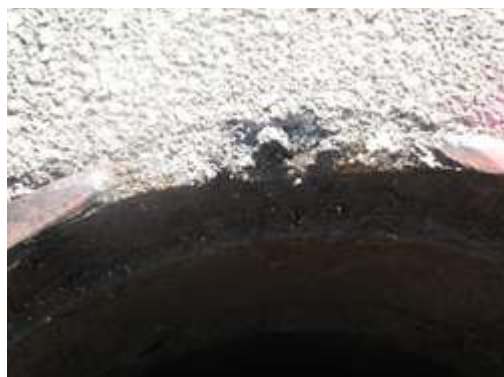
Defect

Cracked frame.

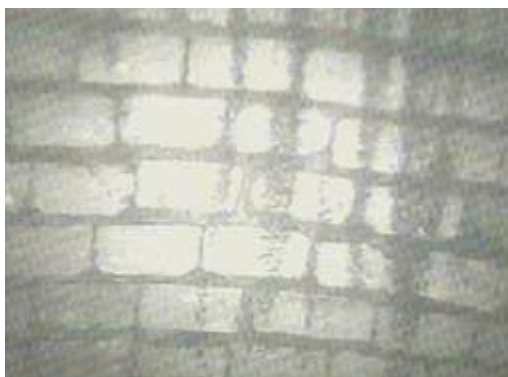
Defect

Barrel infiltration.

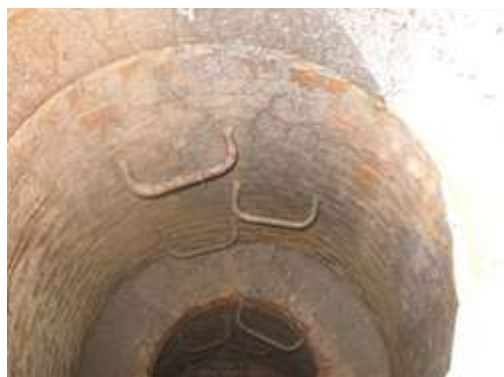
Defect

Frame leaks. Adjustment deterioration and infiltration.

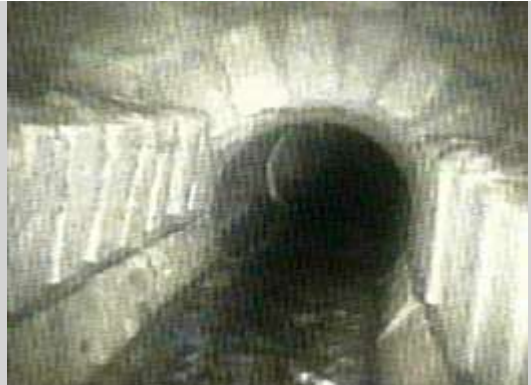
8 in. Circular Gravity Sewer Pipe Out @ 12 O'Clock

Channel deterioration.

Infiltration: **Evidence** Pipe Seal Cond: **Unknown**

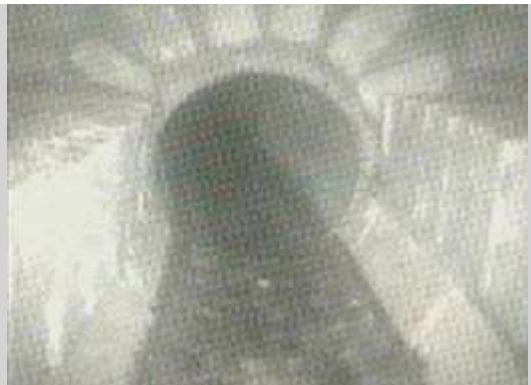
8 in. Circular Gravity Sewer Pipe In @ 6 O'Clock

Infiltration: **Evidence** Pipe Seal Cond: **Unknown**
